Historic Building Information

SHEPPERLANDS FARM,
PARK LANE, FINCHAMPSTEAD, BERKSHIRE, RG40 4QF

The Building

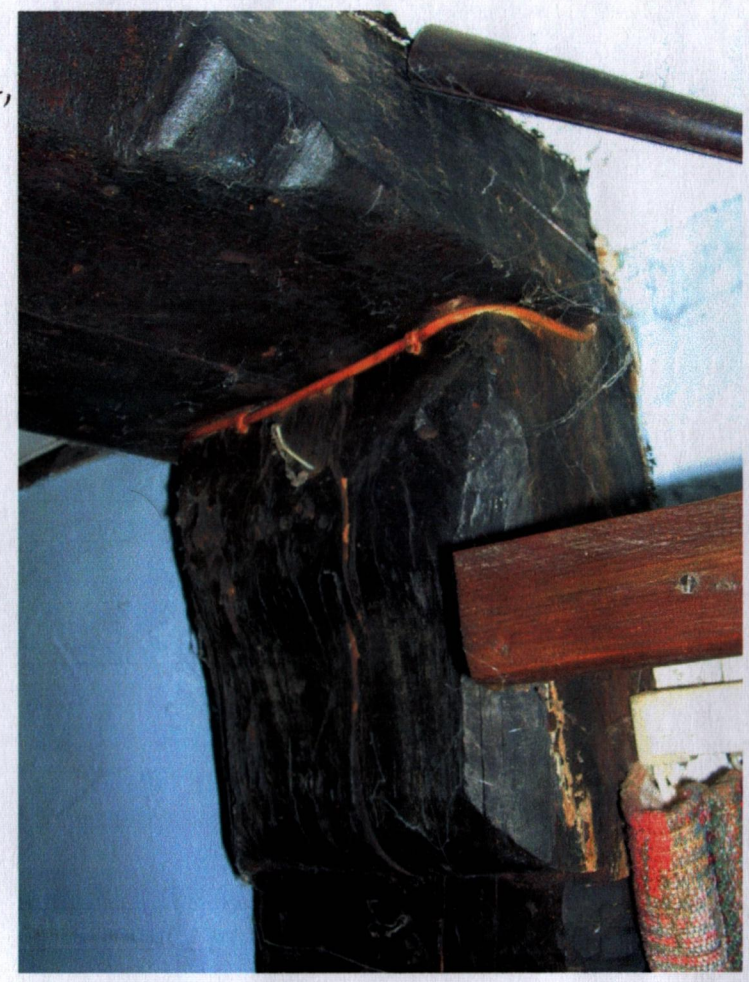
Crosswing, NW side,
Towled Post.

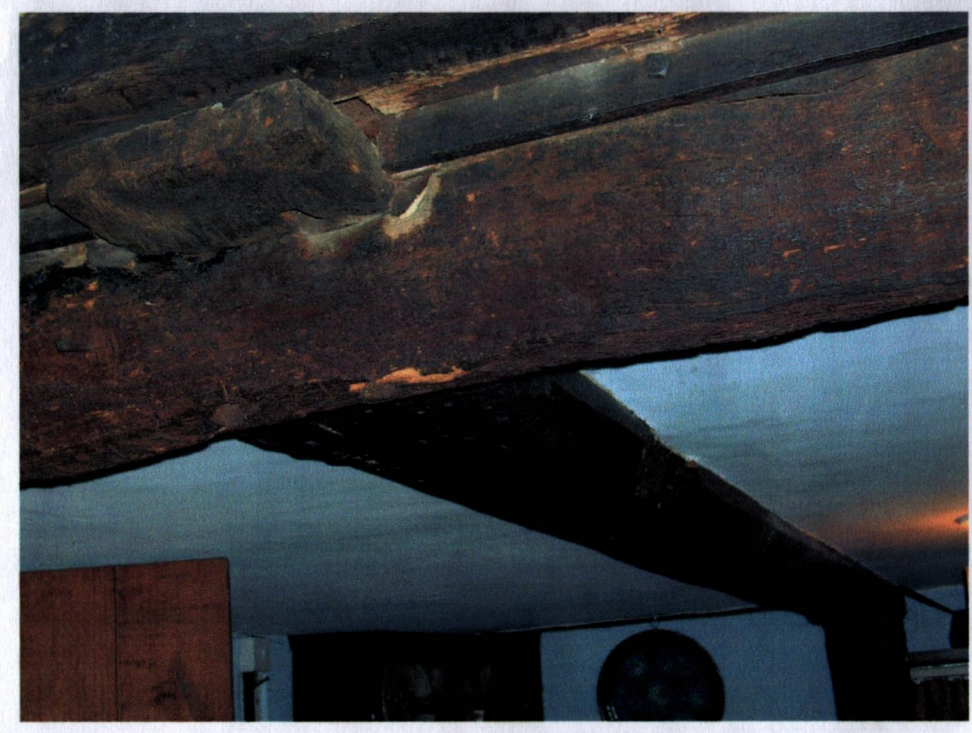
Ogee stop on
transverse beam

Crosswing: transverse beam, SE end tenoned through bressumer.
Chamfer and charring on bressumer suggest former hearth use.

The ground floor bressumer, (referred to in the cross-wing paragraph), has a shallow upward curve cut away in the central portion, behind which a deep chamfer is cut (photo page 9); the chamfer showing signs of charring. This suggests the direction in which the opening for a hearth may have faced, in this case, somewhat unusually towards the cross-wing, as opposed to the hall. From the bressumer, an area of approximately 2 feet extends into the hall, before the axial beam of the hall starts, which runs SE. The NW end of the axial beam has shading which suggests it was at one time seated into a deeper surface than its present joint, which butts against a replacement beam; potentially the lost chimney stack.

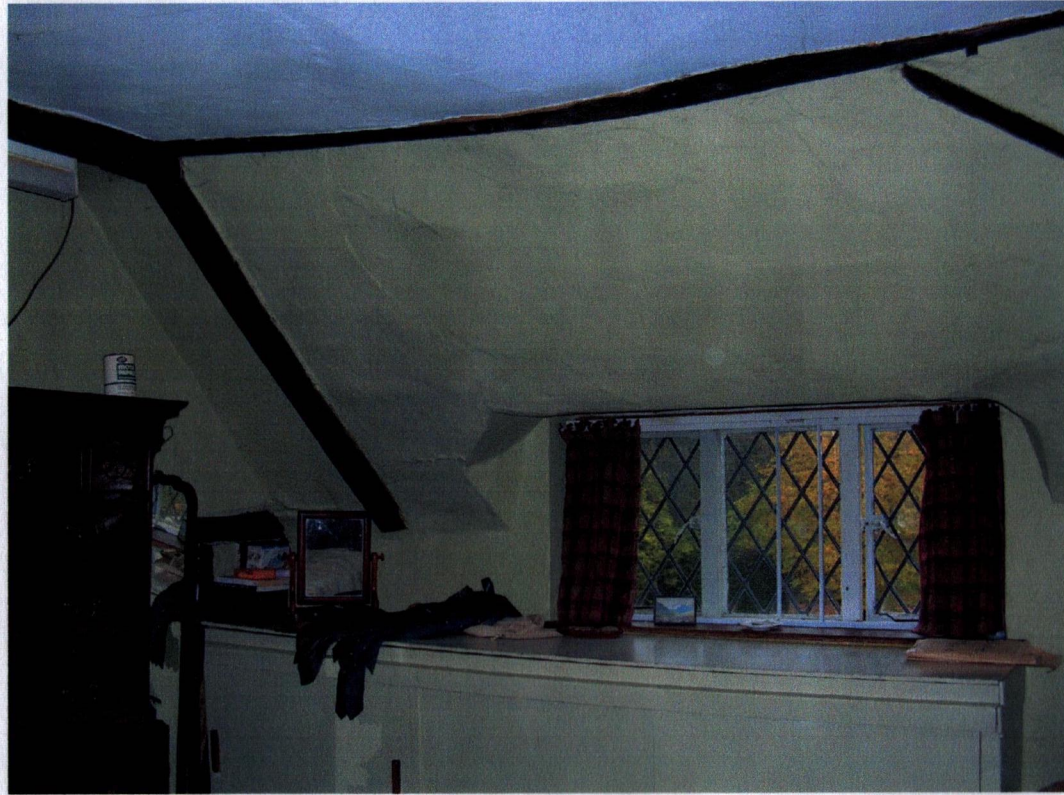
1st floor of hall looking NE.
The rafter and collar to the left, mark the line of the probable smoke-bay.
Note wind brace top right (visible in photo below on the left).

The junction between the hall and cross-wing is separated by what is best described as a very short bay (to left of top photo page 11), and probably indicates the surviving timbers of a smoke bay. It is likely that the stack would have been wattle & daub, as stave holes are visible in both the surviving portion of tie beam and rafters in the upper framing of the hall (top photo Page13), as well as the rafters visible within the loft, which show a smoky line where the partition between chimney and hall would have been. Additionally, later softwood rafters are confined to the narrow area which would have been occupied by the presumed smoke bay.

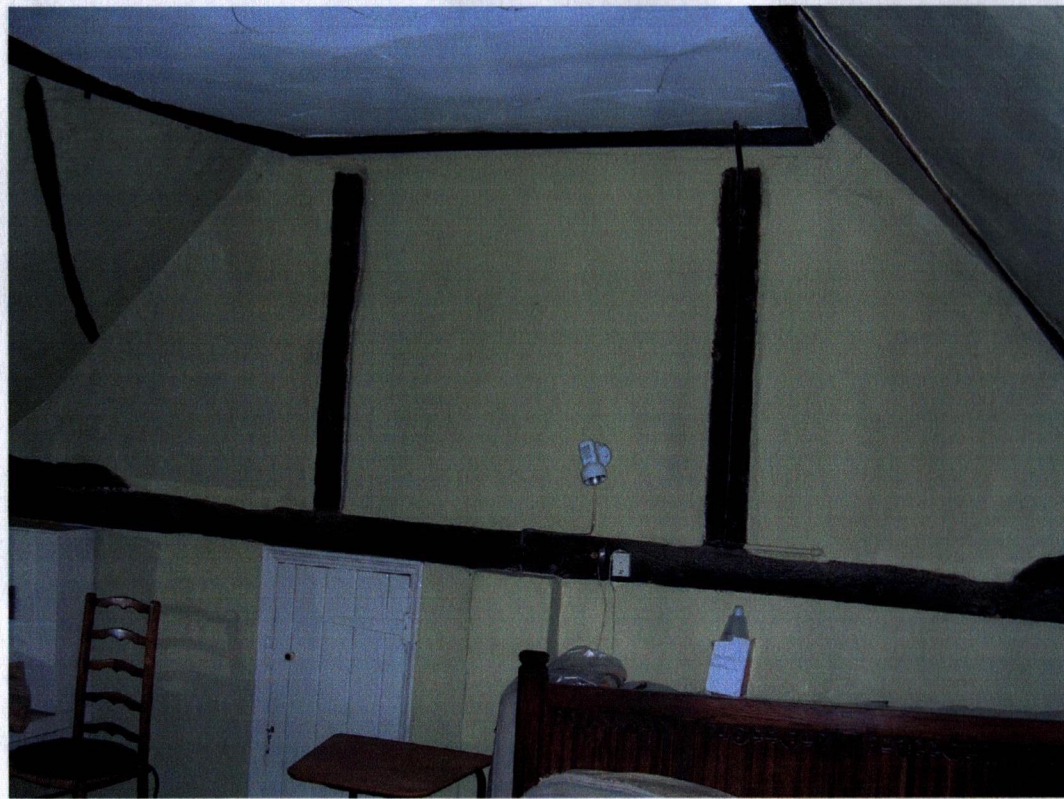
1st floor of hall looking SE. Queen-posts & tie-beam replace originals, however, ends of tie-beams are visible on extreme left & right.

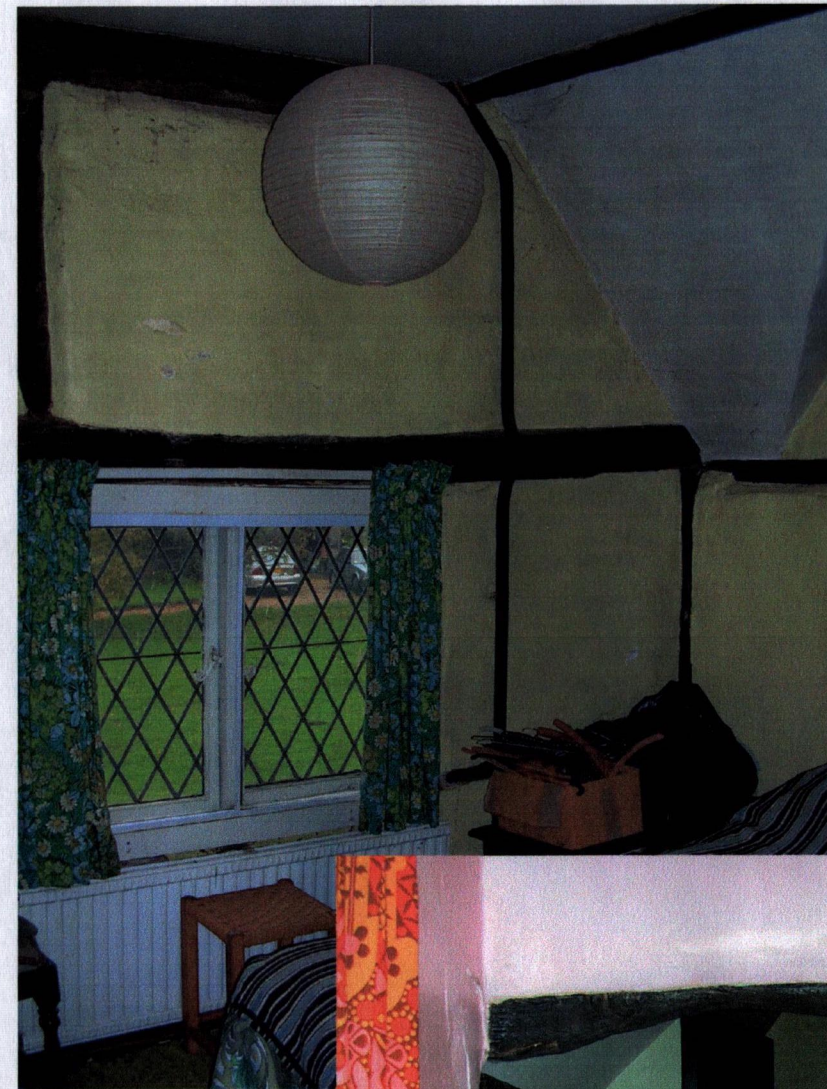
Cross-wing
1st floor room
looking NE.

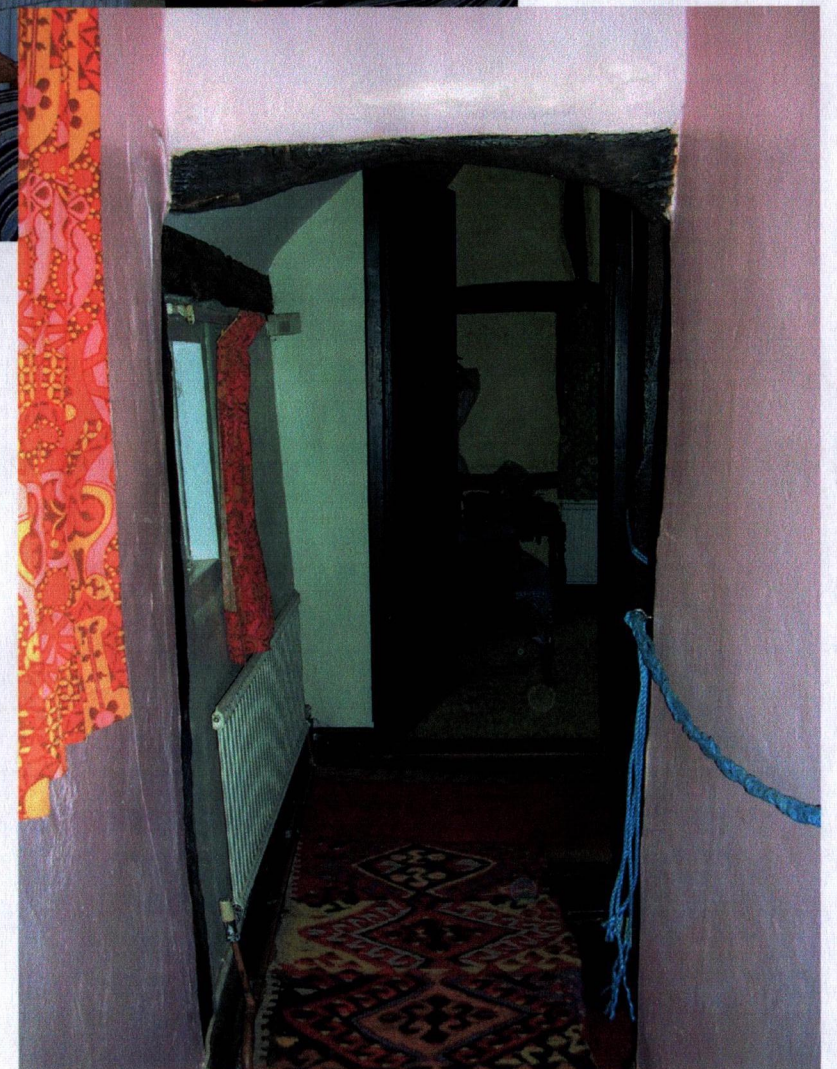
Looking NE from
phase 2 into cross-wing.
Upper curved timber
marks end wall, cut
through for access.

Access to the phase 2 part of the building is via an opening in the SW wall at the top of the staircase; the tie-beam has a curved portion cut away from its underside to increase headroom, and mortise slots are visible on the side of the original corner post, where a horizontal timber has been cut away to form an opening (photo page 10).

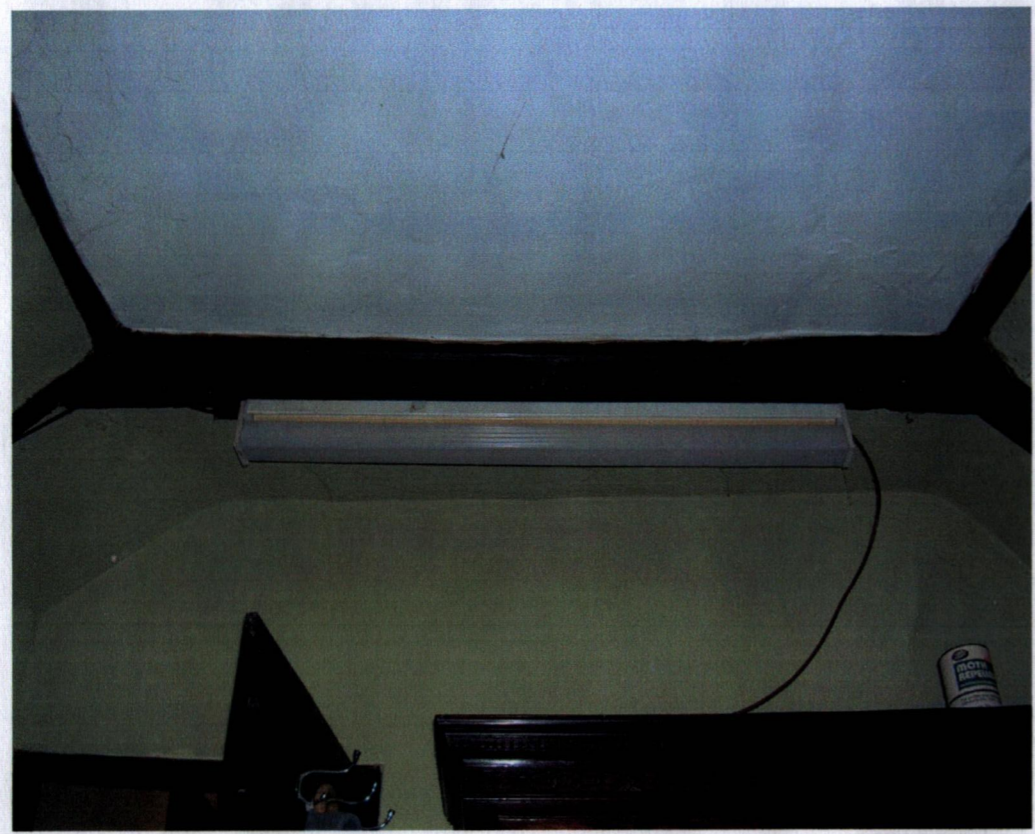
1st floor hall, NW end. Collar (with attached strip light) has stove holes to underside, indicating former panel for smoke bay.

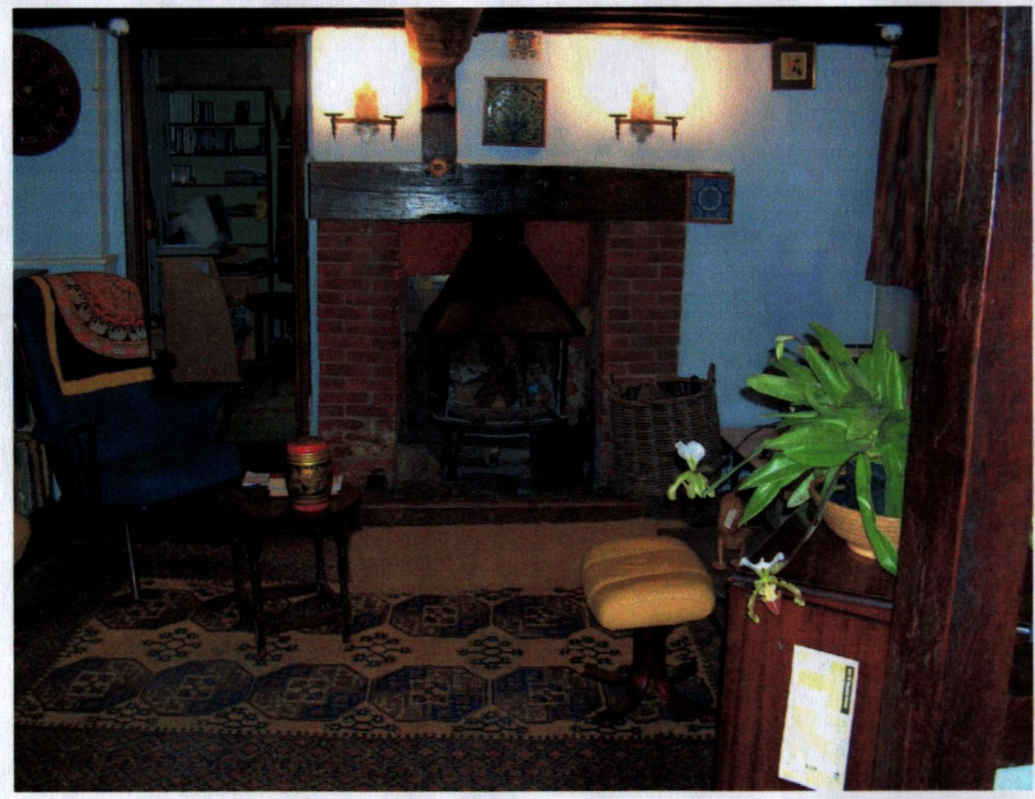
Ground floor looking SE. Axial beam is visible top centre, with joists off to left and right, and inserted fire place ahead.

The adjoining hall has a ground and upper floor, with no sign of having been an open hall. The timbers of the ground floor ceiling are exposed, with joists running into a central axial beam (photo page 13), although their appearance has been affected by a fire (confined to that part of the building) which took place during the 1920's. On the 1st floor, the ends of the original tie beams are visible at the SE end, which have been cut off at either side after a short length, and subsequently joined to an inserted tie beam (re-used early timber), from which two queen struts (also added), rise to the current ceiling level (photo page 11); two straight and rather lightweight wind braces are visible at the SE end, as are side purlins running the length of the room. A tie beam at the NW end probably associated with a smoke bay has been cut away to enlarge room space, however, a further tie beam at the NW end survives (barring a short door way cut out), under which survives a section of vertical riven studding visible on the N side (photo page 12).

A chimney stack has been added to the SE end of the hall, with the hearth opening both to the hall, and the SE extension (photo page 13). Throughout this part of the building, and particularly upstairs, the plaster work does not appear to be modern, although there is obviously new plaster where repairs to the roof have taken place.

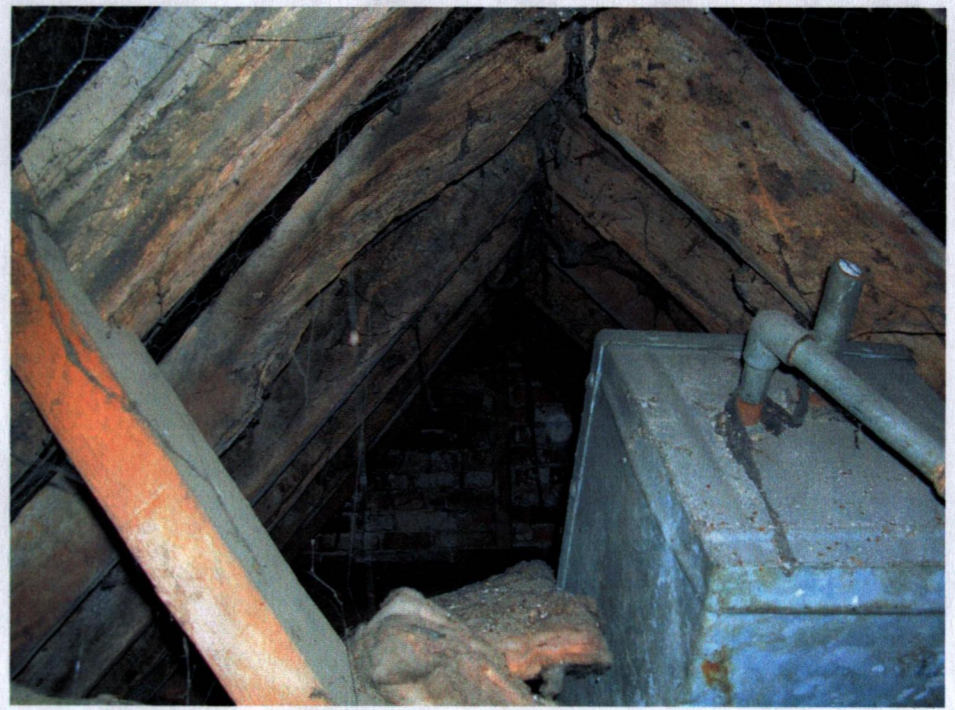
Early rafters over hall, turned at 90°.

The rafters over the hall have been subject to some repair, and whilst are in all likelihood the original timbers, most have been turned 90 degrees, and their apex joints cut away, and replaced with a ridge board (photo page 12).

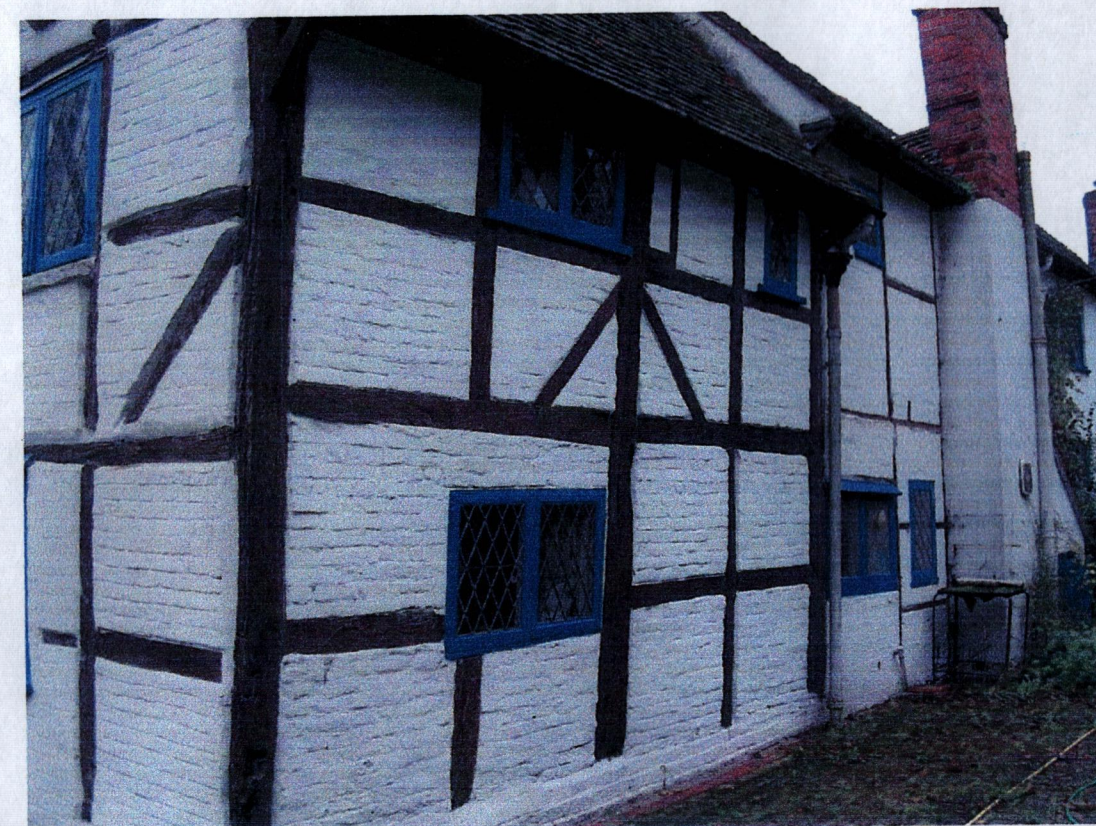
Exterior : NW side

NW side has some light sectioned exposed timber framing infilled with brick, presumably an attempt at the time of building to provide token respect to the framing of phase 1; three timber casement windows are situated to the left of the outside chimney stack (photo page 14). Phase three is smooth rendered and painted, with timber casement windows, with a small timber porch added to the SE exterior (SW end).

As referred to earlier, the cill beam has gone and the vertical framing is now supported on a brick plinth. The NW face has predominantly original timber, with some minor replacements; the unfortunate insertion of a window on the ground floor has cut through two intermediate studs in the left lower side, and is the only loss to this area of framing, in which the carpenter's marks survive in sufficient quantity, that the sequence of construction is wholly described, (see photo page 14 and diagram on page 15). The windows are mid 20th C timber casements with diamond leaded lights.

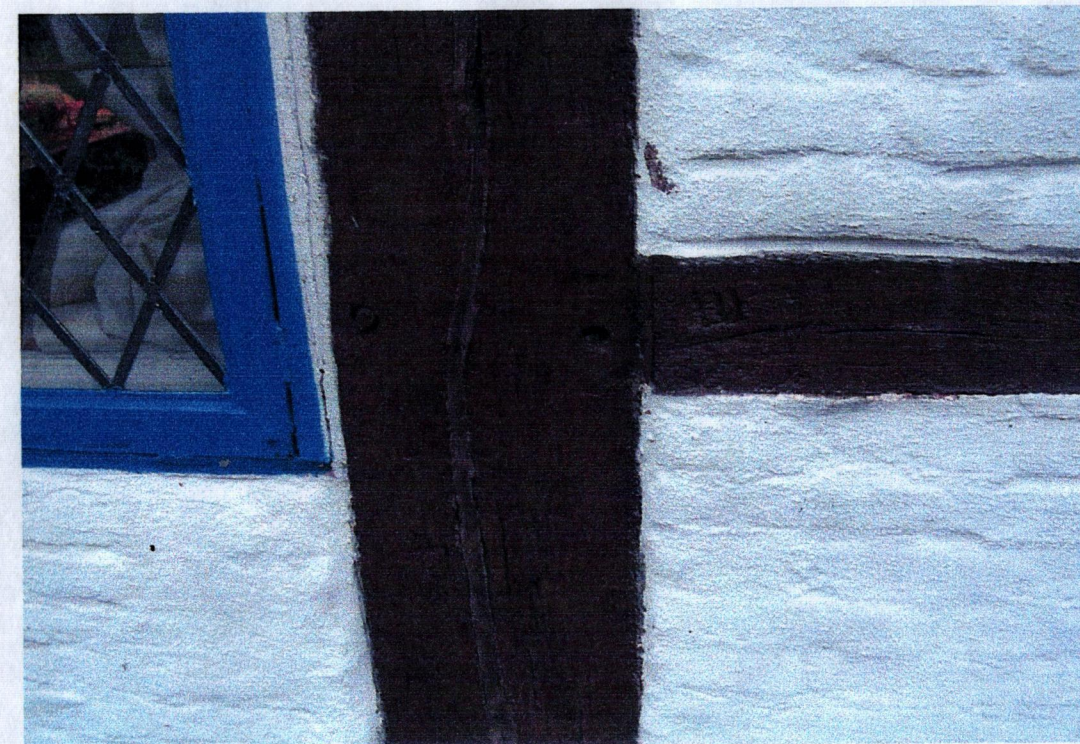
Exterior: carpenter's mark detail

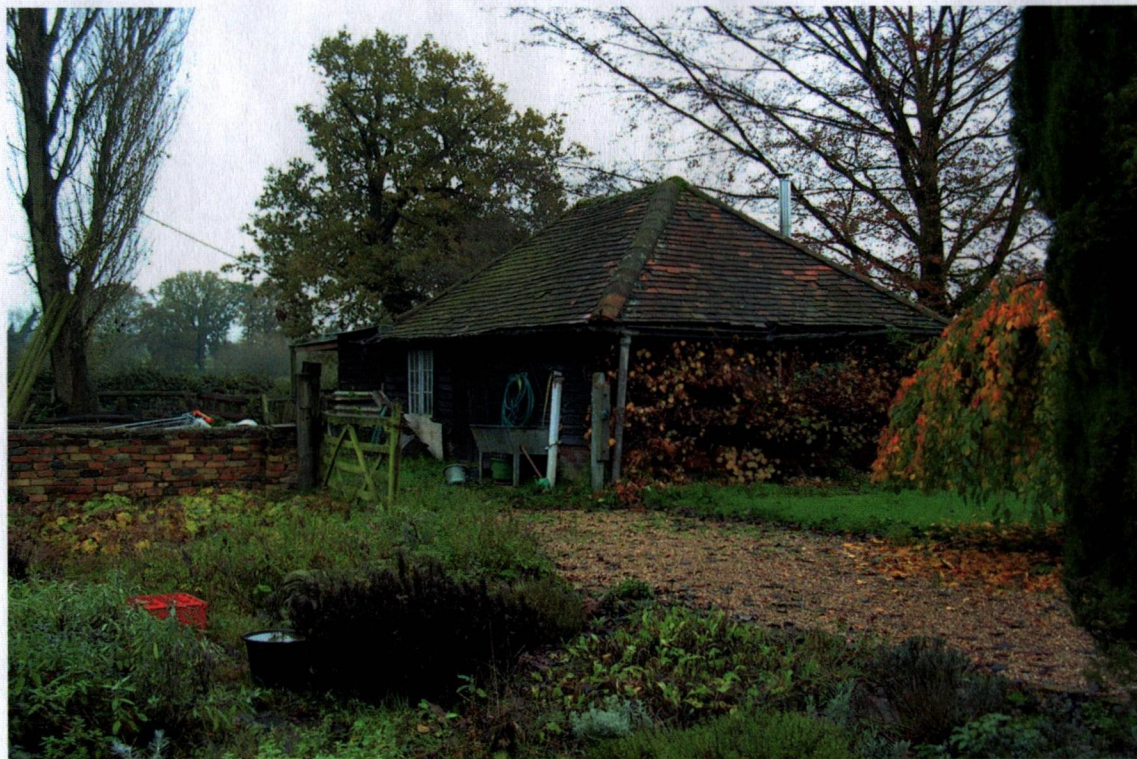
Clay-tiled & weather-boarded 19th C. outbuilding. East of house.

On entering the present drive, an early 20thC timber garage is situated to the NE, and a short way further along, a 19thC farm building lies a short way off to the SW; it is single story, weather-boarded with a single casement window, and a clay tiled hipped roof (photo Page 17).

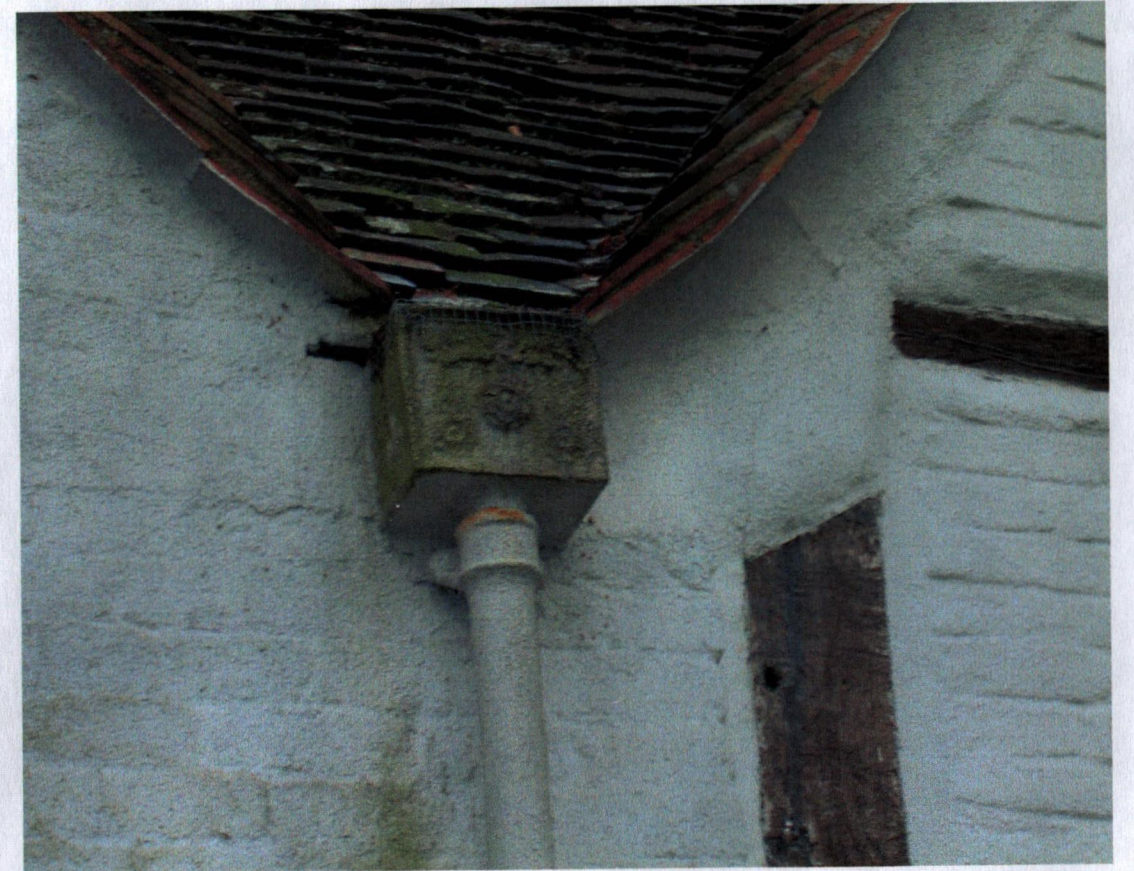
Exterior: NE side:
Detail of rainwater hopper at the junction of the gables.

The NE wall of the hall end of phase 1 has been faced with bricks and no framing is visible (see frontispiece). A gable has been inserted into the roof to allow space for a window, the insertion of which would have cut through the wall plate. At the junction of the two gables, a decorated lead rainwater hopper collects water which then runs into a cast iron down pipe (photo page 16).

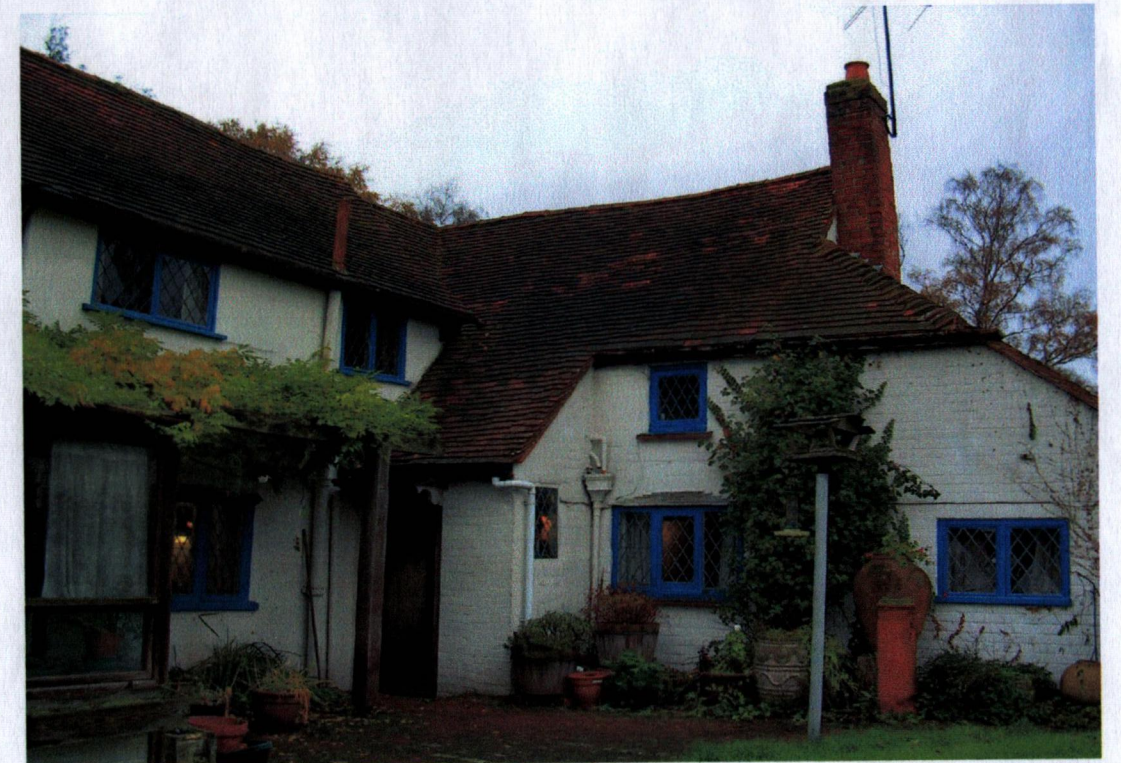
View from the rear. Phase 1 to the right, phase 2 to the left, looking N.

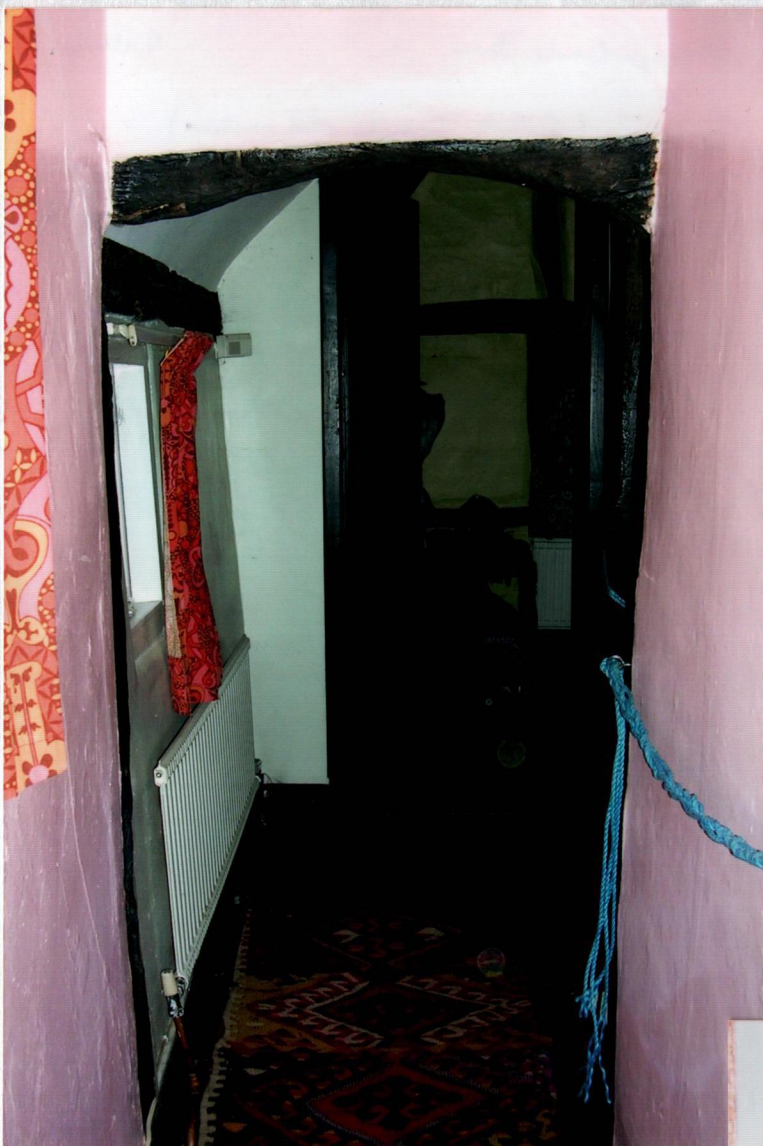
Looking NE from
phase 2 (with cross wing)
upper curved timber
marks end wall, cut
through for access

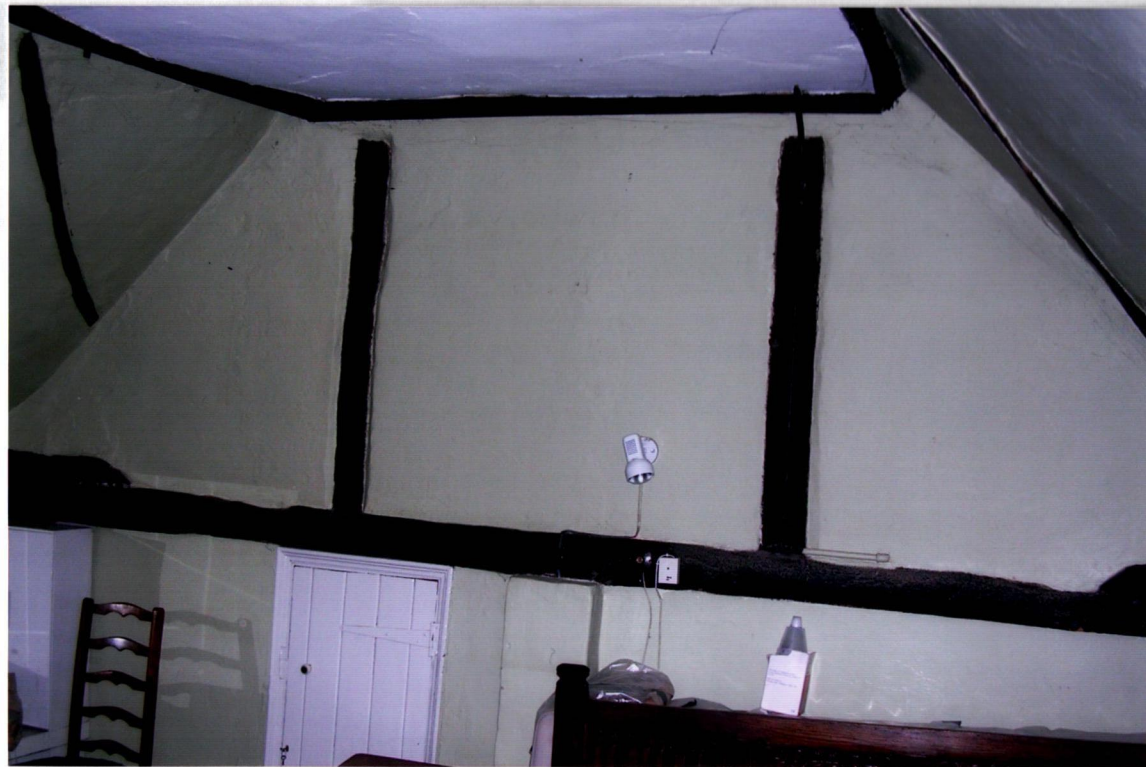
1st floor of hall looking SE
Queen posts and tie beam replace originals,
however, ends of tie beams are visible on
extreme left and right

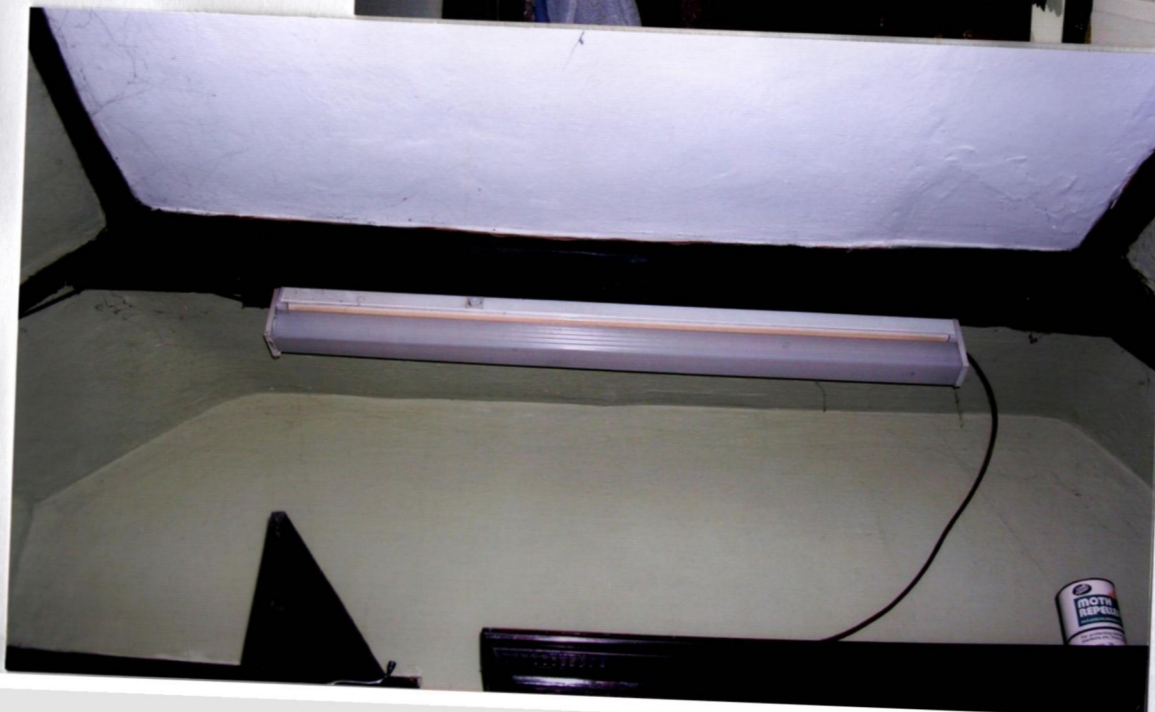
1st floor hall
NW end
collar (with
attached strip
light) have
saw holes to
underside,
indicating
former panel
of smoke bay
